Category: 3.9b. Top Fuselage

## 14/07/2017 - Drill out engine mount brackets - 3h30

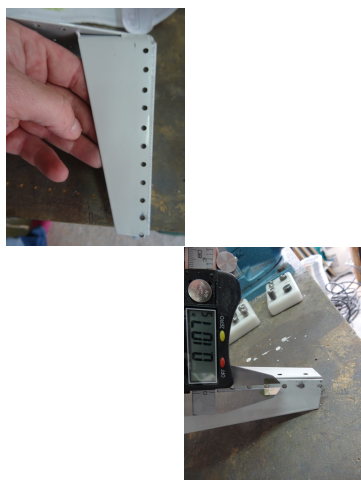
This is the looks of the right side bracket. The edge distance is not sufficient but still reasonable here. From the edge of the bracket to the side of the hole I have 0.107" where it should read minimal 0.1875"

You see also that the last hole on the bracket is useless as it's drilled lengthwise near the end of the bracket. There is no way I can fix that as the hole is already drilled in the longeron and there is insufficient space between the 2 last rivets to put one in between. I guess that last hole will not be critical if all the rest has good edge distance.

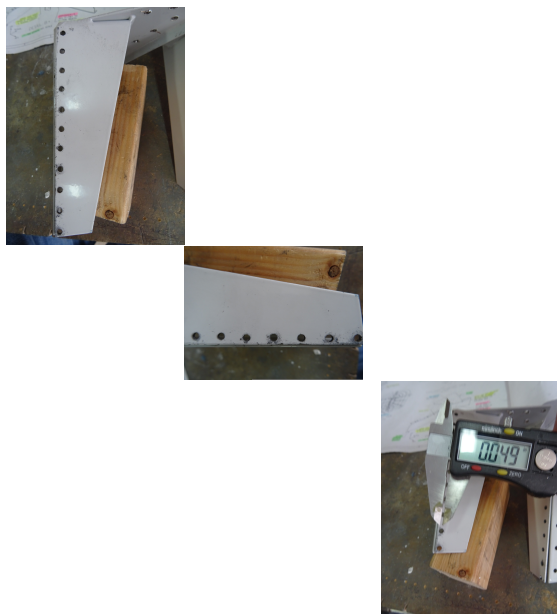
Here is the left side. This side is even more dramatic. Have a look at the bottom (rear) of the bracket). I'm so happy I took these off and checked.

Only 0.049" from the edge to the edge of the hole. That's definitely not enough.

Will order new brackets soon and in the meanwhile I'm going to experiment a bit with some aluminum bar the same gauge and test how far I can get with edge distance with proper clamping. Hopefully that will be ok because I don't feel like replacing longerons.
