Category: 6.10 Sam James Cowling

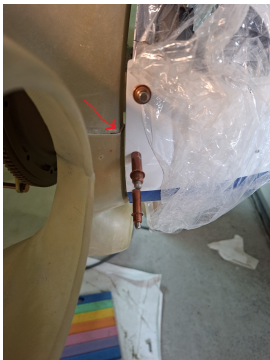
Here is what I mean with unstressed mating. I have been having to pull the passenger side top cowl down and clamp it on the skybolt bracket. This causes the joint at the spinner to distort and shift which moves them out of alignment. My root cause analysis here is that there is still too much material in the joggle between the air intake and the spinner. This causes tension which moves the cowls alignment. I will sand more down here and see how it evolves and if this results in less clamping force needed on the outside

Looking at this from the front, I marked with a blue sharpiepen where I believe the area is that causes the stress. I will use a sanding board to bring this down some more and see how it evolves.

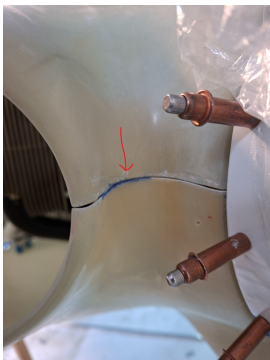
From the side view, you can see that there is a small gap between top and bottom cowl. Not dramatic, but I want to get rid of that clamping

force required to keep it there.

After some more sanding, the fit is already better and I'll keep checking more after taking on and off the cowl a couple times more. I think I took the top cowl a hundred times on and off already in the passed weeks and I'm sure it won't be the last time.

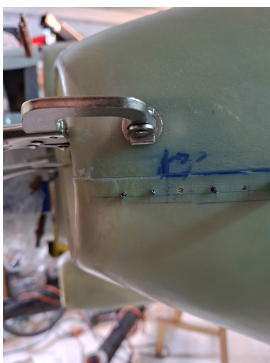
On the pilot side, all looks very well and there is no pushing or clamping force required to keep the top cowl in line with the bottom cowl split line. Having it this tight in the front meant I had to sand a little more a few inches back towards my last drilled cleco in the middle. I marked this again in blue and with the long sanding block, removed some more glass from the top cowl.

All good now between last #30 cleco and front and I drilled 2 more holes moving forward. I took out some alternate cleco adapters from the back and moved them forward.
