Category: 3.11. Empennage mounting

## 02/07/2020 - Redrilling elevator horn after rewelding - 4h

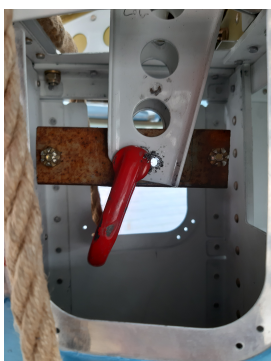
The edge distance on my horns were ok but even though I used a drill block in between the horns, I managed to get the holes vertically misaligned. The bolt was tilted slightly down.

Reason being that I used a hard-wood drill block. Tip for you, get some cast iron block when you drill the horns.

This time the holes align perfectly ! Very pleased with the result.

The drilling needs to be very accurate this time as I no longer have a #40 pilot hole but need to drill to final size #12 from the first time.

I made a cast iron drill block instead of wood in the previous attempt

and sandwiched it between the horns secured by a c-clamp.
