Proceeding on the forward fuselage, the next step is installation of the F-902L and R bulkheads.

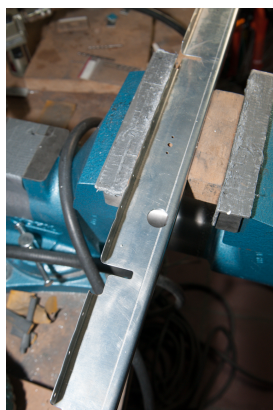
As a first manipulation, I took out my step drills to enlarge the hole for the rudder cable. The pilot hole is already there, so this is a walk in the parc.

You should also make a relief notch on the other side of the flange so that you have a clear passage for the cable. I didn't do this yet but have to make a reminder to self not to forget it.

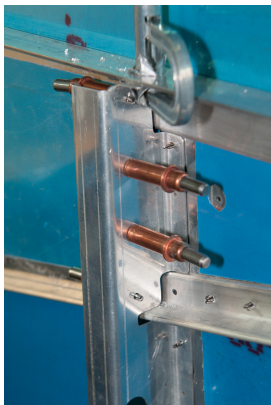
When clecoing the F-713 auxiliary longerons in place, I noticed that I couldn't get the F-7101 to sit nicely between F-713 and F-717. Even not after rounding the corners. This is where a bell should have started ringing, but what I did was grinding away a bit of the top side of the F-7101. This way, I could fit F-7101 between both longerons. Nobody got hurt at this stage (but it ruined 2 parts... without noticing). You can see the notch in the picture below. (DON'T DO THIS !)

Next, I drilled the 4 holes that mate the F-7101 flange with the F-902 bulkhead.

The result below

So what do I need to do next... order a new set of F-713 and F-7101's. All by all, it's not a disaster and just some days work are lost. Things could have been much worse but it's another sigh of relief and a lesson learned the hard way.
