## Matchdrilling spars 29/12/2010 - 8h10m

Category: 1.1 Horizontal Stabilo

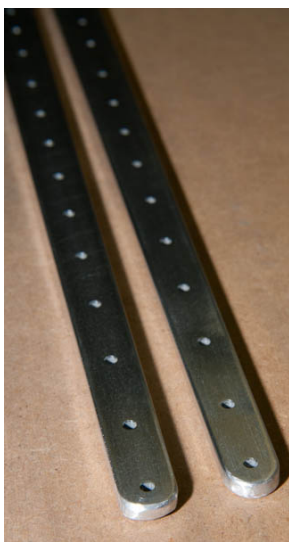
To eliminate any potential stress points, I removed the mill marks on the material first with the mini scotchbrite on the die grinder and then further polishing it down as much as possible. I read on the site of [Dalton Zeigler](#) that Vans employee Bruce Reynolds mailed him that polishing down to 0.015" is allowed. At some point I had to convince myself to stop. In the end, you keep on rubbing the metal for the smallest possible little scratch you can see.

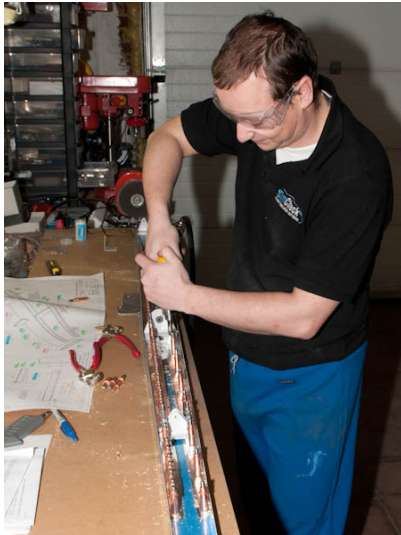
I then started match drilling the bars on the spar with the #30 drill for the AN470-4 rivets.

After all the main connection points were drilled, match drilled the hinges HS412PP (left) and HS413PP (right) to #30.

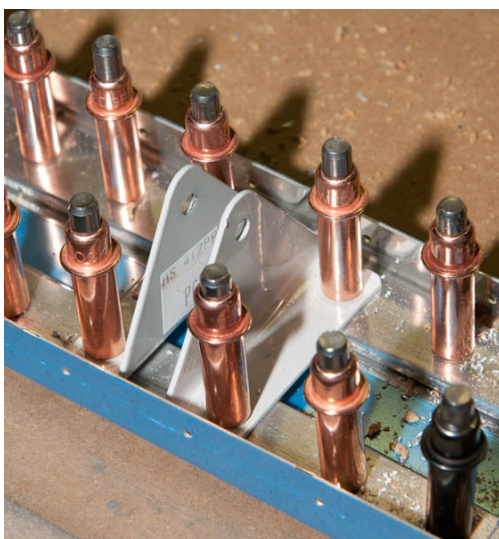
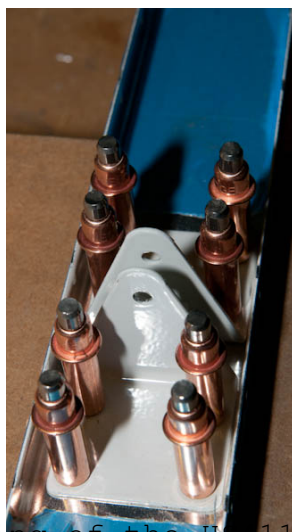
Drilled the position of the attaching middle rib to #21. (see black cleco in the picture below)

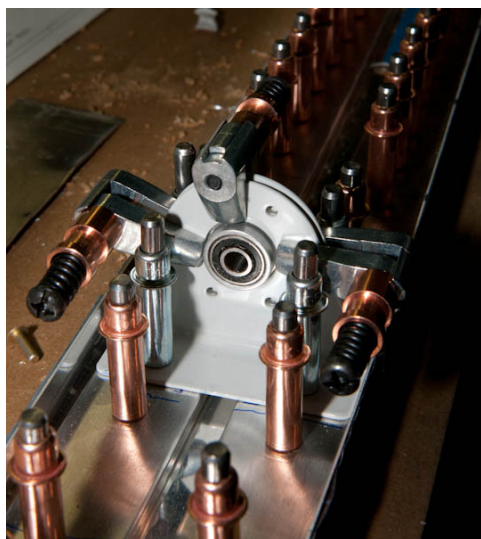
Next step is the positioning of the HS411APP and HS411BPP. Only HS411BPP is pre-drilled. Insert the VA146 bearing and clamp together with cleco clamps when assembled on the spar.

Clamped in place:
