## Center fuselage rivettingskin 9/6/2014

Category: 3.8. Center Fuselage

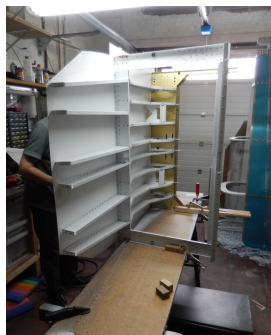
In this worksession, started rivetting the bottom skin to the skeleton structure of the center fuselage. I actually did this in a couple of smaller sessions but didn't get the time yet to update the weblog. I started of by turning the center fuselage upside down on some sawhorses with wood support but found out that the position to buck underneath was just too painful to maintain this for longer periods. The picture below shows the best way I found to rivet. I put a wood plate on 2 sawhorses and clamped the center fuselage to it on it's side.

Then rivetted the bottom side as close as possible to the bottom. Then flipped the whole structure over to rivet the other side (to avoid too much moving while rivetting).

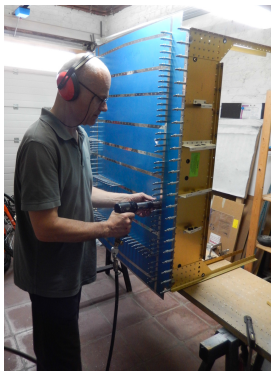
Use that blue painter tape to protect the ribs while bucking.

A normal tungsten bucking bar will do the job, but it's even easier using a tungster with one side angled.

I had to use -4 length rivets instead of 3.5 because of the thickness of the primer. 4 was just too long and made the rivetting difficult but 3.5 was just too short.

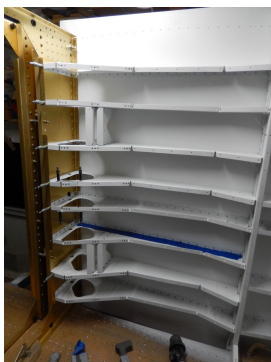
At one spot, we really ran into a problem. Had to drill out a AD3-4 rivet out multiple times. The reason we found out is that the dimple was damaged near the bottom side and the hole in the rib was slightly oval. Because of that, the rivet kept tilting downwards. We decided to up-drill to #30 and set a AD4-4 rivet. The drilling went fine and dimpling apparently also, but when setting the rivet (which still is slightly down), we noticed a small crack on the top of the dimple.

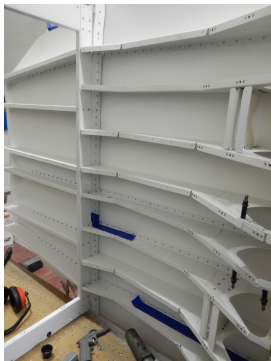
Location of this cracked dimple in the rib is where the blue tape is near the bulkhead for the seatrests.

*I had some problems setting one rivet near the intersection of F705 bulkhead, F776 center bottom skin and F716 inboard seat rib. After having to drill out the rivet a couple of times, the dimple looked deformed on the bottom side.*

*However, after setting, we noticed a crack in the upper side of the dimple. Probable occurred while using the pop dimpler for 1/8. I removed some primer to take the picture attached so the bare material is visible. The crack is only in the dimple of the rib, not in the skin*

*We decided to up-drill to #30, pop dimple for 1/8 and set a AN426AD4 rivet in the original hole. The final rivet is not perfect but it is acceptable.*

*This can be disregarded as an issue. Build on...*
