## 19/03/2025 - Leg fairings (p4) - 3h

Category: 4.5. Fairings

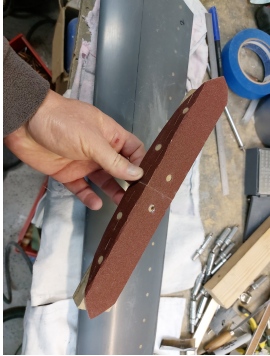
Made a long sanding block 100 grit. This will help sanding down the trailing edge of the gearleg fairing up to the earlier drawn line (according to the template).

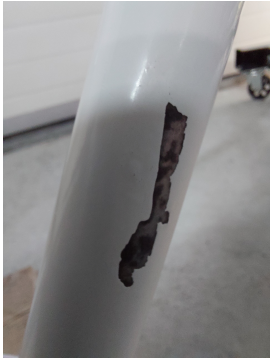
I decided to take of my flexible brake line. The bottom side is too short and interferes with the bottom of my fairing. I'll remake this line with a solid 1/4" aluminium line as per the plans. When I cut off my electrical tape that held the line on the front of the gear leg, I discovered this problem. A large chip of paint came off the landing

gear.

I asked Vans what to do as they don't have the touch up powder coat anymore in the webstore. Vans Support told me to scuff it up and cover with the regular 2 component primer I used on the rest of the plane.

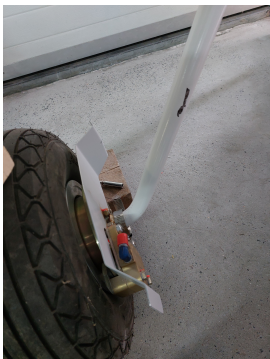
It's a rather large chip so I was a bit worried on the reason why this came off. I couldn't discover any corrosion. It may have been a "non-clean" part when it was painted at the factory. I will keep monitoring this in the future to see if any more places get problems with paint. For now I covered it with some LP3 rust inhibitor to protect it and will spray paint it soon.

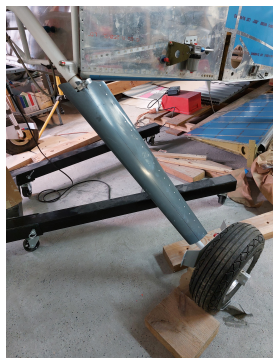
Overall, this looks really good and is almost ready for final alignment.
