Category: 4.5. Fairings

Today, repeated the same procedure on the passenger side fairing as on the pilot side. My procedure worked well so I followed the same approach.

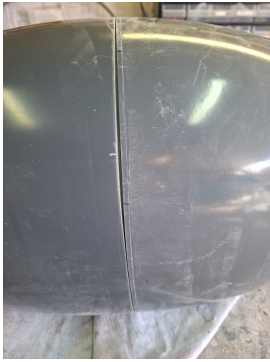
On the passenger side fairing, the gap on the joint was even bigger so it needs a lot of love to get it right. The image below shows the worst gap.

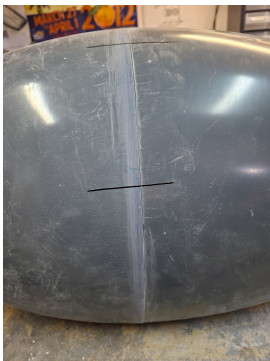
After some hours of work and a lot of epoxy dust later, the result looks like in the image below. Again made the reference lines across the parts to reposition the parts in the same location each time you fit and remove again.

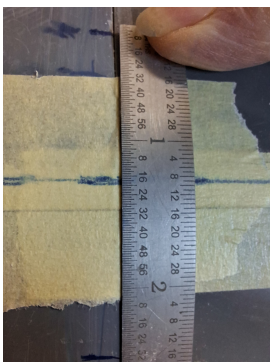
Then cross checked my centerline again by measuring from left and right side up. Distance between the marks is  $2\frac{1}{2}$ ", the center line occurs near perfectly at  $1\frac{1}{4}$ "

The picture may not be perfect as the ruler wasn't fully pressed down on the mark. I'm confident my centerline is good.

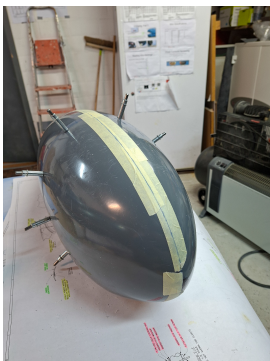
Next positioned the drill holes and drilled the fairing to #40.
