## 07/01/2019 - Center cover repair - 2H

Category: 3.9. Forward and Center fuselage

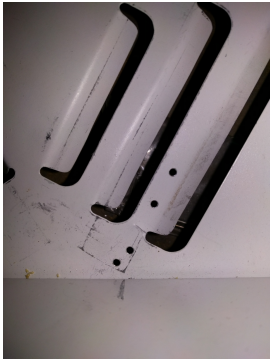
I got a crack in the pilot side lower vent while clamping. You can see the crack in the picture below.

For repairing, I decided to cut the vent and place a doubler plate of 0.025" on supported on each side by two AN426AD3 rivet.

Made the plate.

Cut the crack out and sanded all smooth.

Now primed it and waiting for the paint to set before I can rivet it on.
