Category: 2.9. Wing mating

## 19/05/2020 - Drilled the holes mating the wings - 10h

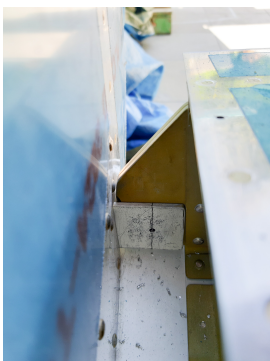
I immediatly checked the position of the hole on the forward part of the fork and saw that my vertical line indicating the predicted location of the hole was quite accurate. Edge distance on the fork looks perfect.

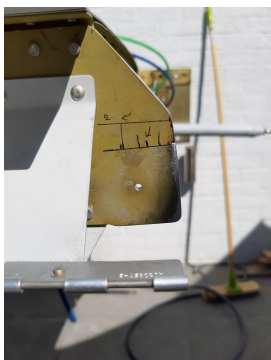
As you can see in the pictures below, edge distance is fantastic on all parts.

Het is the rear spar on the left wing.

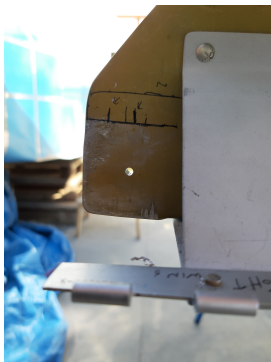
Rear spar on the right wing.

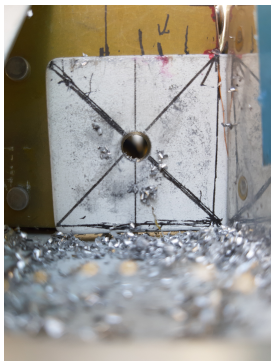
Then it was time to enlarge the hole for the final AN5 bolt size on the left wing. I used an undersize drill bit and finally enlarged with various reamers until I got a snug fit of the AN5 bolt in the hole.

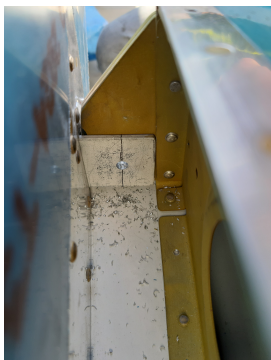
All still looks good.

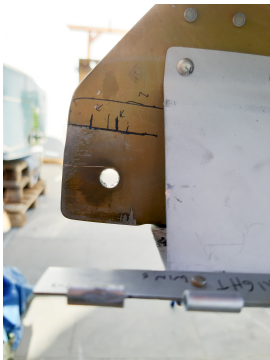
As you can see, there's plenty of edge distance in the rear spar attach.

One thing worried me a bit. Although I used a drill block to make the initial pilot hole and have it straight, I found out that the bolt sits a bit tilted in the fork. Reason, using the wrong rivet line to look if the drill bit was held straight.

I hate it when such stupid things happen. I contacted Vans support on this and suggested to add some filed washers on an angle to support this and have a flat surface.

"Filling a set of washers to match these angles and gluing them to the face of the fuselage bars would be an acceptable work around and is all I would attempt to do. Other than that what you have appears to be perfectly acceptable. I expect this assembly would be fine without the filed washers but if you add them it arguably should be on both sides so the bolt head and nut are on flat mating surfaces. Might require the next size up bolt be used."
