## 22/05/2020 - Adjusting flap gap with fuselage - 2h

Category: 2.9. Wing mating

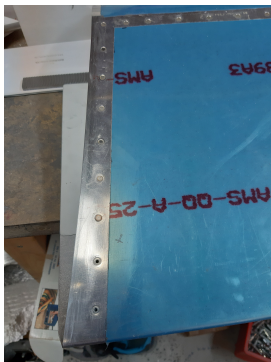
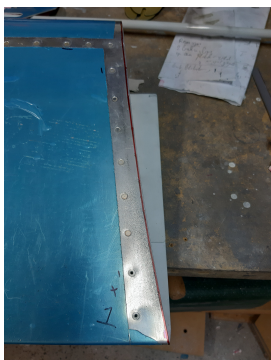
Same process on the other flap.
