I started work on the aileron gap fairings and the flap braces. These are 2 long ribs of aluminum that are rivetted to the rear spar of the main wing structure.

## Aileron fairings - 13/09/2012

Category: 2.4. Main Wings

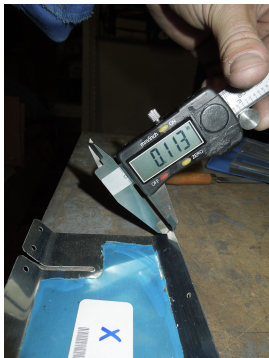
The holes on the bent flange are not well aligned and are too close to the edge. On the other hand it's nicely in the middle so it means the part was slightly shifted while punching.

Look at the holes on the left on the picture below, the hole is very close to the edge. Way less than is acceptable for edge distance. Moreover, as this is part of the aileron system, I really don't want to take any risk here.

We should have at least 0.17 here and the measured 0.11 is far off. I documented and sent the pictures to Vans Support and they promised to send me a replacement piece free of cost.

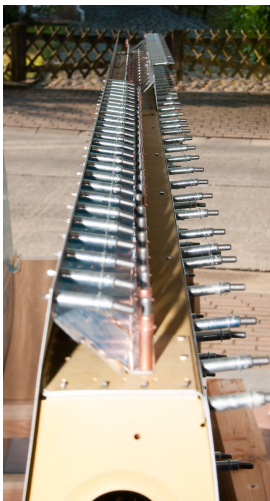
Length wise view of both : you clearly see the opposite directions of the parts.
