## 01/12/25 - Horizontal split line (cntd) - 2h

Category: 6.10 Sam James Cowling

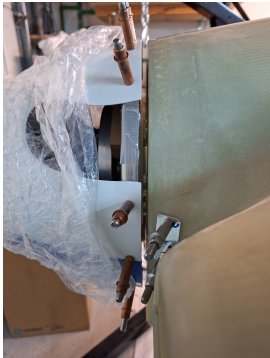
Not a long session but enough to drill the front holes in the top cowl to 15/32" and fit the cowling using all the side line SkyBolts.

I was a little disappointed after all those measurements and moving forward with drilling in steps that I saw there is a minor gap between top and bottom cowl in the front.

It's not a big deal, it's epoxy so it can be easily filled and there needs to be a 0.05" gap for painting in the end. But it's never nice to see it didn't end up the way you accurately worked towards it.

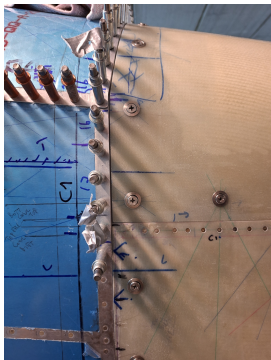
The intersection at the firewall side, small gap but within painting gap tolerances as well. No need for filling.
