Finally after all those preparations and small tasks, the body is coming together for a last and final time and it's rivetting time.

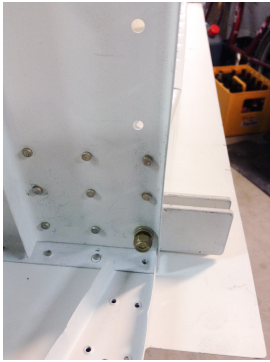
First I squeezed the two upper rivets holding the outer seat rib to the F-705 bulkhead on both sides. This would be difficult to do with the skin on. (The outer 2 rivets in the picture above the an3 bolt.

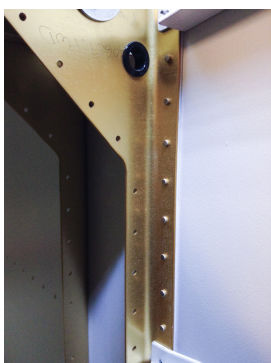
After Hugo left, I had some energy left and bolted down the lower aux longerons to the steel engine mount brackets. Torqued these AN3s to 25 inch/lbs and sealed them.

They might interfere with rivetting the bottom skin but we'll deal with that when we get to that. Good torque on these was very important for me.
