Category: 3.9b. Top Fuselage

Continued on the fuselage gussets. In the last session I drilled them to the longeron.

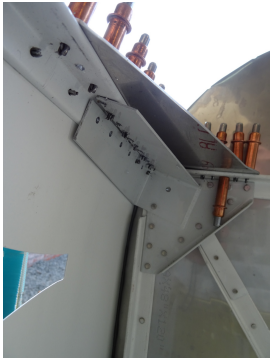
As I mentioned earlier, I had serious doubts about the edge distance on the top leg of the engine mount bracket.

A closer look already reveals the problem... The upper leg is lengthwise not flush with the inside of the longeron angle, instead, it's angled inward towards the end which makes edge distance smaller and small towards the end.

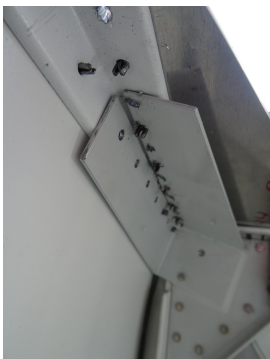
Removed the gussets and took this picture to illustrate the extra bend.

Here you can see the location of the small additional bend in the gusset

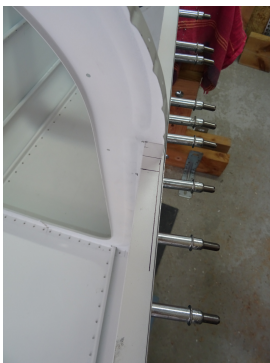
To position the anchor, you have to draw a lengthwise alignment line  $1/8$ " from the outboard edge of the longeron. Then measure a horizontal line at  $17/32$ " from the front of the F708 bulkhead. The most backward line is my reference line perpendicular on the front of the F708. The second one (forward) is the one where the bolt will be centered.

Clamped the anchor parallel to the lengthwise line and showing the forward line through the back hole of the anchor.

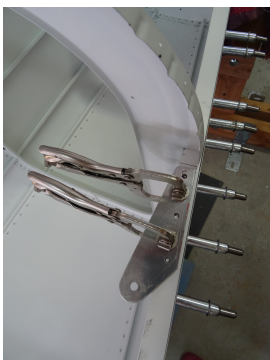
Drilled and clecoed 3/16.

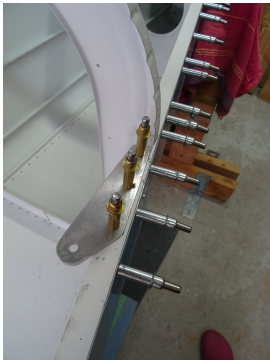
Good edge distance overall.

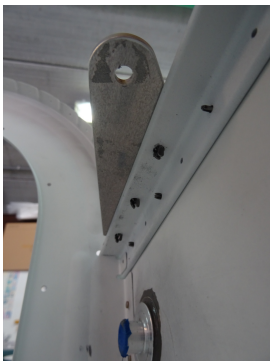
Here's a view with both passenger and pilot side drilled.

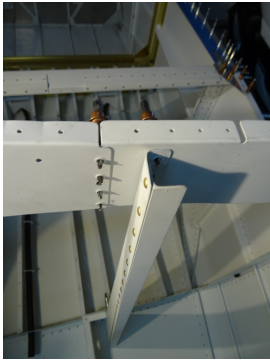
Next I noticed that I forgot to dimple the vertical line where the F-728A channel attached to the F706 bulkhead. I rivetted the channel and angle at an earlier stage so all I had to do left was to dimple the holes for #30 and rivet it together.

Don't rivet the row on the left side (in the picture) just yet as the F787 stiffener web will attach also at that location.

Tried to rivet the connection of the bellcrank channel with the 706 and I set two rivets. I tilted both of them. Started cursing and called it a night... I'll get back to this when my nerves cool down. Vans mentions in the plans that this is a difficult location and allows CS4-4 pop rivets in the lower three holes and that's probably
