## 12/07/2023 - Flap motor safety wiring SB - 4h

Vans safety bulletin SB07-4-12 from 2007 indicates that the flapmotor pushrod has to be safetied in the bolt assembly to ensure the pushrod cannot rotate and unscrew itself.

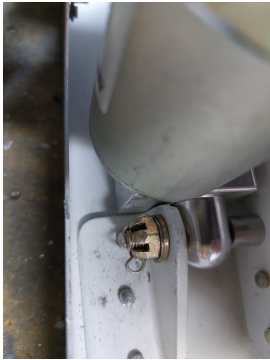
I first installed the bolt and castle nut that hold the flap motor and installed a cotter pin.

I thightened the lock nut first.

The took some safety wire and installed it as er instructions in the safety bulletin. The safety wire is looping over the washer and then insert through a drilled hole in the pushrod. The hole was drilled already in a previous worksession so I just needed to safety wire this.
