## 05/01/2019 - F-7114 gusset positioning and heat baffles - 5H

Category: 3.9. Forward and Center fuselage

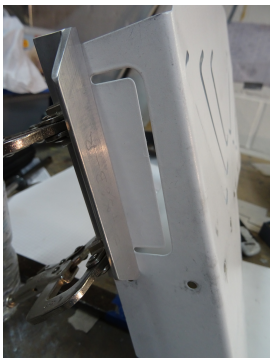
You have to clamp a piece of angle and bend the tab outwards. The manual states you can do this by hand but this is not really true. I had to tap with a small wood block to be able to open it up.

You need to clamp both sides before bending ! Ask me how I learned...

The material is extremely flimsy and cracks if you don't ... see next article...
